DON'T GIVE UP ON CORRODED FITTINGS

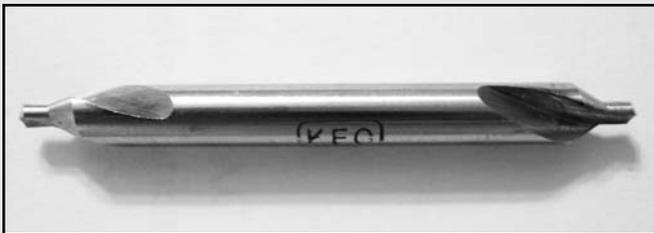
Figure 80. This is a No. 3 centering drill bit. The centering bit is 7/64-inch in diameter (to produce a 1/8-inch hole) and the bit depth also is 7/64-inch (0.110-inch), so it just goes through a 0.105-inch thick nut.

Inject plenty of penetrating solvent into the joint and give it time to work. But how? You can spray a little onto the threads at each end of the fitting, but that probably won't do it. In addition, use a No. 3 centering bit (Figure 80) to drill a small hole through the midpoint of one of the flats of the hex fitting - the bit is 7/64-inch diameter and has a depth of 7/64-inch. (Figure 81)

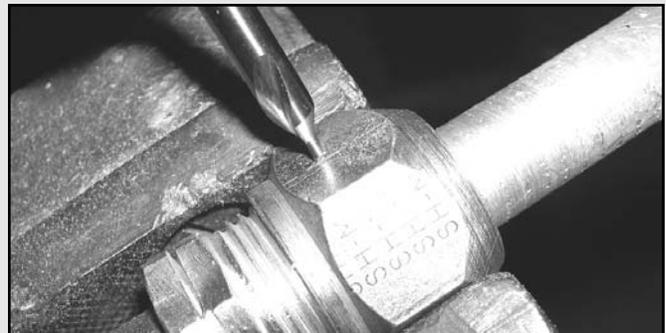
Figure 81. Drill through the midpoint of one of the flats on the female hex, as shown. Don't force the drill and stop as soon as you can feel it go through. For illustrative purposes, we set up these photographs at a workbench.

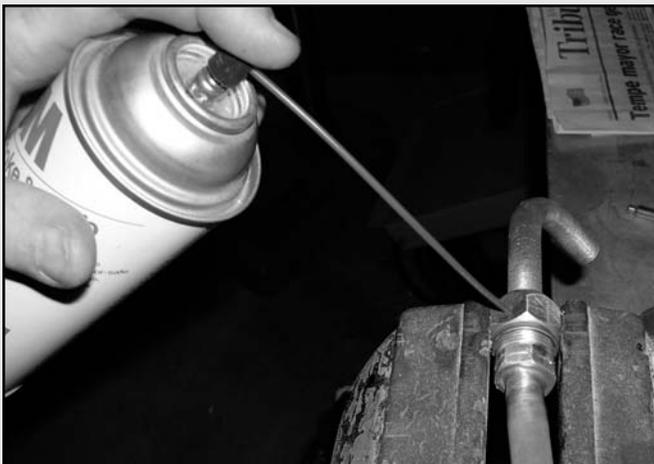
Figure 82. The centering drill bit will produce a hole that's large enough for the straw of an aerosol can. Spray penetrating solvent through the drilled hole. Also spray solvent into each end of the fitting, and after the solvent works in, the fitting should loosen.

Then, using an aerosol can of lubricant, insert the straw through the hole and spray (Figure 82). Because you're also spraying

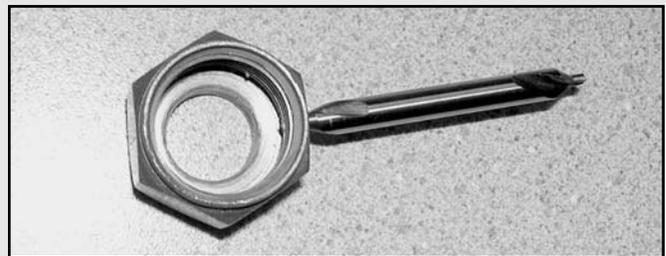
Figure 83. Close-up of the centering drill bit inserted through the fitting nut. The bit barely protrudes past the peak of the threads, so at worst it would put a minor nick on the edge of the fitting's male threads (if it went all the way through). A slight dressing with a thread file or cleanup with tap-and-die set should be all that's necessary, making this approach a lot easier than cutting out the fitting and installing a joint of some type as a repair.

However, we actually miked the pieces involved. The nut was 0.105-inch thick, and the No. 3 centering drill bit's tip - if it went all the way in - was a whisker under 0.110-inch thick (7/64-inch), which could produce a minor nick that probably would clean up with a thread file, tap or die. In our test case, we didn't force the drill, so although it went through, it didn't seem to produce a visible nick, although the very tip of the drill did protrude ever so slightly (Figure 83).
